Smoke and Dye Testing Summary

High Level Sewershed

Test ID	Test Type	Date Inspected	Company / Super.	Blower MH	Ground Condition	Notification Made?	Total Length
S1028-245	Smoke	8/25/2009	ADS/TM	S2100_013MH	Dry	Yes	508.98

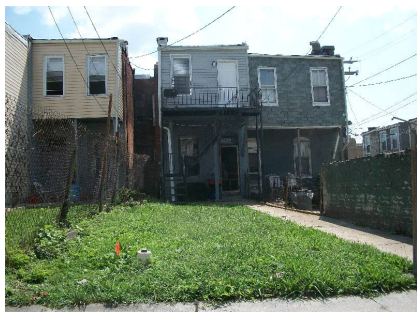
Picture \S1028-245-OB01-P01.jpg

Source Service Lateral

Location Yard - back

Comments Smoke from service lateral in back yard. 2304 Fulton Ave.

Comments Back of house, 2304 Fulton Ave.

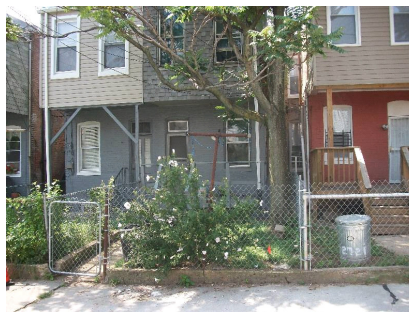
Picture \S1028-245-OB02-P01.jpg

Source Service Lateral

Location Yard - back

Comments Smoke from service lateral in back yard. 2719 Parkwood Ave.

Comments Back of house, 2719 Parkwood Ave.

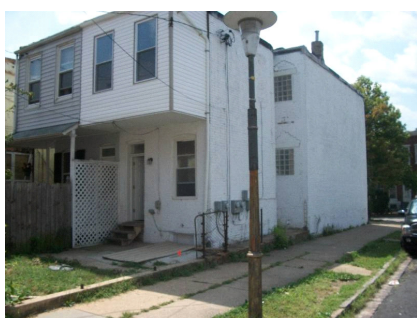
Picture \S1028-245-OB03-P01.jpg

Source Service Lateral

Location Paved concrete

Comments Smoke from service lateral in paved concrete behind house. 2731 Parkwood Ave.

Comments Back of house, 2731 Parkwood Ave.

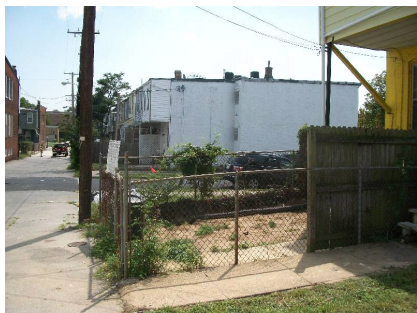
Picture \S1028-245-OB05-P01.jpg

Source Service Lateral

Location Yard - back

Comments Smoke from service lateral along fence in back yard. 2803 Parkwood Ave.

Comments Back of house, 2803 Parkwood Ave.

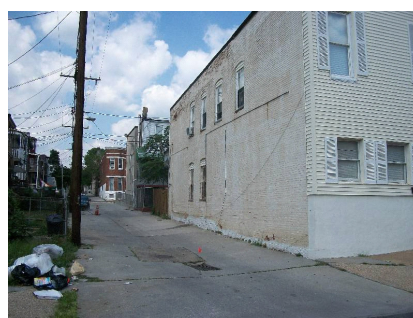
Picture \S1028-245-OB04-P01.jpg

Source Catch Basin

Location Alley

Comments Smoke from catch basin in alley behind 2801 Parkwood Ave.

Comments Alley behind 2801 Parkwood Ave. looking northwest

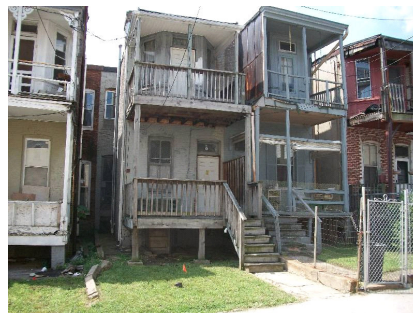
Picture \S1028-245-OB06-P01.jpg

Source Cleanout

Location Yard - back

Comments Smoke from above-grade cleanout in back yard. 2807 Parkwood Ave.

Comments Back of house, 2807 Parkwood Ave.
